Magician Lake 2019 Aquatic Vegetation, Water Quality, and 2020 Management Recommendations Report

December 2019

© Restorative Lake Sciences 18406 West Spring Lake Road Spring Lake, Michigan 49456 Email: <u>info@restorativelakesciences.com</u> Website: http://www.restorativelakesciences.com

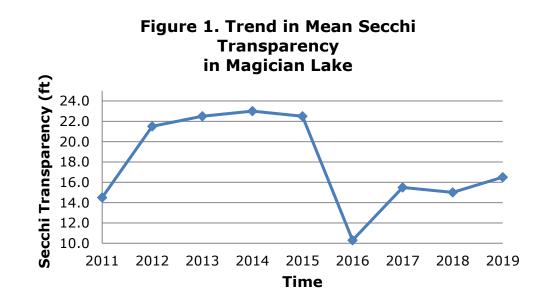
Elevated Secchi transparency readings allow for more aquatic plant and algae growth. The transparency throughout Magician Lake in August of 2019 was adequate (mean of 16.5 feet) to allow abundant growth of algae and aquatic plants in the majority of the littoral zone of the lake. Note: Secchi transparency in Magician Lake is much higher in spring and has been around 22-25 feet in recent years. Secchi transparency is variable and depends on the number of suspended particles in the water (often due to windy conditions of lake water mixing) and the amount of sunlight present at the time of measurement. The trend in Secchi transparency is shown in Figure 1 below.

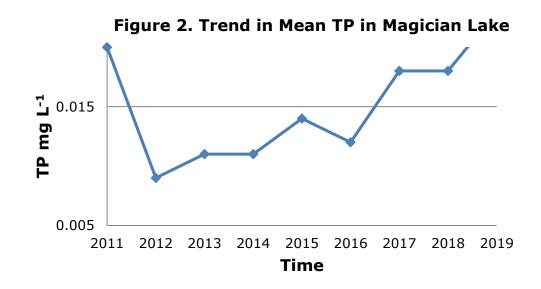
Total phosphorus (TP) is a measure of the amount of phosphorus (P) present in the water column. Phosphorus is the primary nutrient necessary for abundant algae and aquatic plant growth. TP concentrations are usually higher at increased depths due to higher release rates of P from lake sediments under low oxygen (anoxic) conditions. Phosphorus may also be released from sediments as pH increases. TP concentrations ranged from 0.010-0.040 mg/L with the highest values in August of 2019 which is still quite low for an inland lake but expected during seasons with intense rainfall as observed in 2019 (Figure 2).

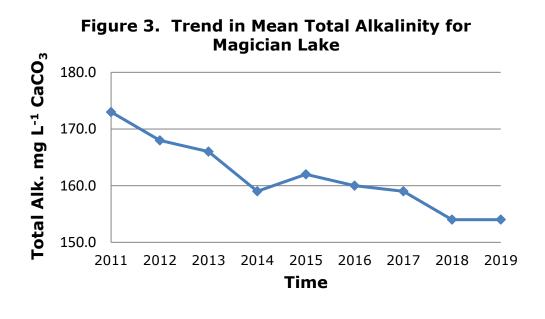
Lakes with high alkalinity (> 150 mg/L of CaCO₃) are able to tolerate larger acid inputs with less change in water column pH. Many Michigan lakes contain high concentrations of CaCO₃ and are categorized as having "hard" water. Total alkalinity may change on a daily basis due to the re-suspension of sedimentary deposits in the water and respond to seasonal changes due to the cyclic turnover of the lake water. The alkalinity of Magician Lake was moderate in August of 2019 with a mean of 154 mg/L of CaCO₃ (Figure 3) and indicates a moderately hard water lake that is well-buffered.

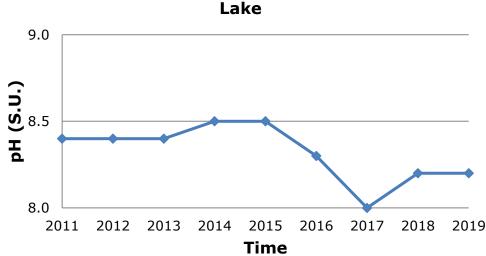
Most Michigan lakes have pH values that range from 6.5 to 9.5. Acidic lakes (pH < 7) are rare in Michigan and are most sensitive to inputs of acidic substances due to a low acid neutralizing capacity (ANC). Magician Lake is considered "slightly basic" on the pH scale. The pH (Figure 4) of Magician Lake in August of 2019 averaged 8.2 S.U. which is ideal for an inland lake.

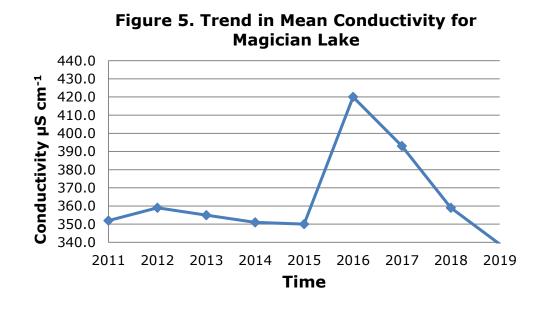
Conductivity is a measure of the number of mineral ions present in the water, especially those of salts and other dissolved inorganic substances. Conductivity generally increases as the amount of dissolved minerals and salts in a lake increases, and also increases as water temperature increases. The conductivity values for Magician Lake were moderate in August of 2019 and ranged from 332-351 µS/cm (Figure 5). Severe water quality impairments do not occur until values exceed 800 µS/cm and are toxic to aquatic life around 1,000 µS/cm.

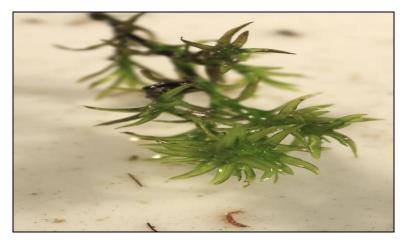
Figure 7. Southern Naiad

The most common native aquatic plant species included: 1) Southern Naiad (Figure 7), which appears as a thin-leaved, bright green colored aquatic plant that lies a foot or so off of the lake bottom, 2) the macro alga Chara (Figure 8), which has a strong, skunky odor and resembles small green nodules that grow along the lake bottom, and 3) Variable-leaf Pondweed (Figure 9), which is a bright green and brown colored small, low-growing pondweed that is often found near the shoreline.

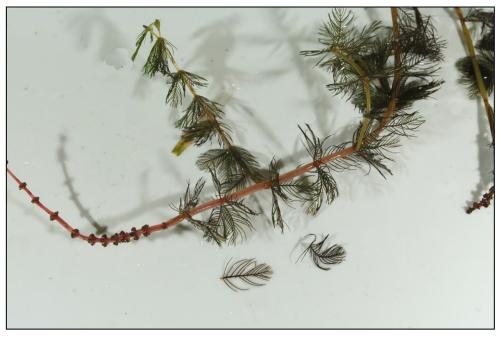
Figure 10. Eurasian Watermilfoil

The amount of Eurasian Watermilfoil (EWM; Figure 10) present in Magician Lake varies each year and is dependent upon climatic conditions, especially runoff-associated nutrients. 2019 experienced intense rainfall events and associated nutrient runoff and many lakes experienced nuisance milfoil and algal outbreaks. The spring 2019 survey revealed that approximately 0.7 acres of EWM was found in the Keeler Township region and 3.5 acres of EWM was found in the Silver Creek Region. On May 31, 2019, the milfoil was treated with high dose granular Triclopyr (Renovate OTF®). The treatment was very successful with only a few stems remaining as of late September of 2019. Also, on May 31, 2019, an algae and diquat treatment were conducted on algae and nuisance Curly-leaf Pondweed (Figure 11) which were present in the southwest canals. Muck pellets were also added to the aerated canal along with two additional algae treatments on July 2 and July 19, 2019.

Due to the relative scarcity of native aquatic vegetation in Magician Lake, the treatment of these species with aquatic herbicides is not recommended (one exception is the overgrowth of nuisance pondweeds in the canals). The plan for 2020 includes the use of high dose systemic aquatic herbicides (triclopyr) for effective treatment of invasive milfoil. Nuisance pondweeds in the canal would respond well to Clipper® at 200-400 ppb. Curly-leaf Pondweed will respond well to Aquathol-K® at 1-2 gallons per acre. Starry Stonewort if found again in the canals will respond well to a mixture of Clipper® at 200 ppb and chelated copper. These two invasives have been well-controlled in recent years.

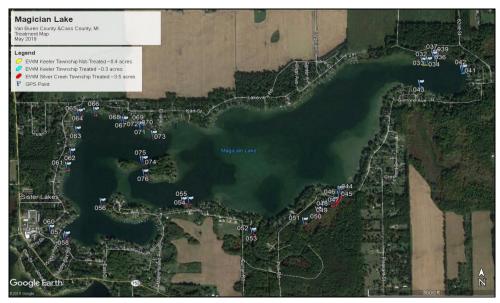
Figure 12. Eurasian Watermilfoil distribution in Magician Lake (May 21, 2019).

Treatment maps for each of these invasive species are shown in the maps below (Figures 12-14).
